EUCLID CHEMICAL

PROJECT PROFILE

ST. GABRIEL'S CATHOLIC CHURCH TOWER RECONSTRUCTION

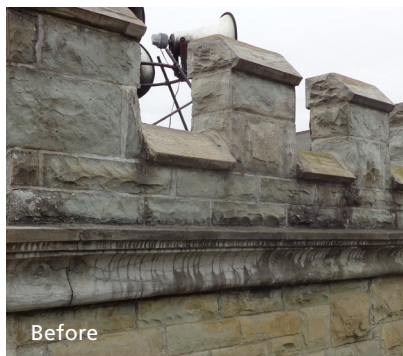
Before

The original cornice at St. Gabriel's Catholic Church, which is over 100 years old, was deteriorating and compromising the stone above. The procedure for this project was to disassemble the stone above, remove the deteriorating cornice, and reconstruct the cornice with an alternative material. The process began with the building of formwork around the perimeter of the tower. Then, epoxy-coated rebar was anchored into the existing brick and concrete layers below using DURAL ICC GEL. DURALPREP A.C. was used to coat all the cut ends of the rebar and the underlying brick and concrete substrate. Following this surface preparation, EUCOREPAIR SCC was poured into the forms and left to cure. Lastly, the stone above was rebuilt on top of the brand new cornice, which was sealed with CHEMSTOP WB.

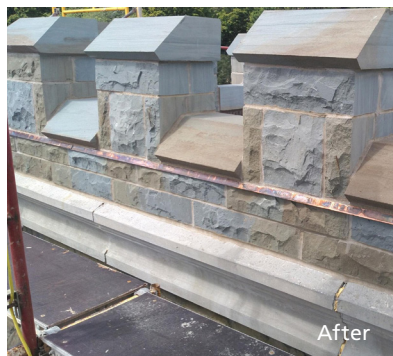
After

The church was seeking to replicate the original, 100-year-old stone cornice with a product that was economical, easily mixed and placed on site, and that would not have any voids, in order to maintain the intricacy of the design. The finished cornice was a tremendous success, and achieved the goal of producing a perfect replica of the original, all while saving costs on material and labor versus other restoration methods.
