EUCLID CHEMICAL

PROJECT PROFILE

PERRY ARCH BRIDGE REHABILITATION

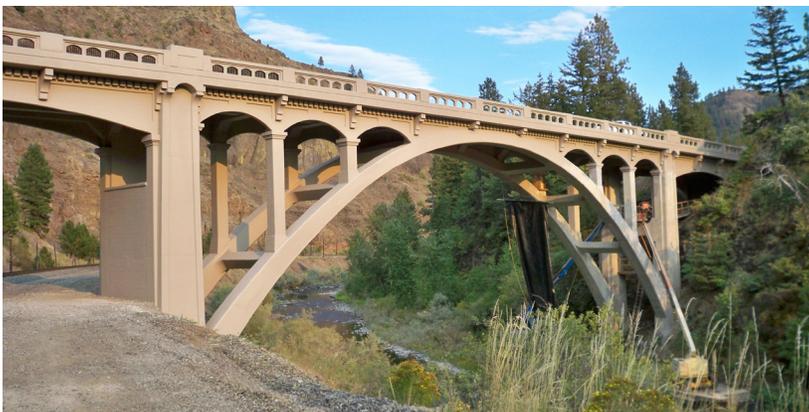
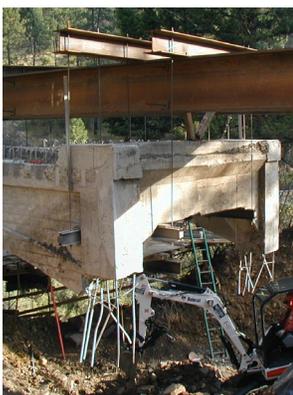
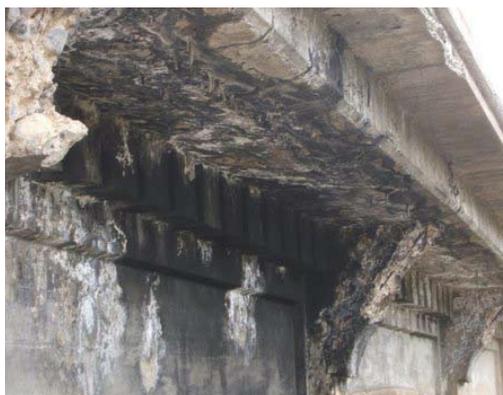
The 22'-8" wide single lane bridge consists of four approach spans which each average 50 feet in length, and one main arch that spans 130 feet. OTAK Inc. served as the engineer during the design and construction process, and the contract was administered by the Oregon Department of Transportation. This work included rehabilitating four approach spans and complete replacement of the span supported by the main arches. All bridge rail, crossbeams, deck, spandrel posts, sidewalk brackets and dentils were demolished and replaced. The arches and bents were salvaged; the cracks were injected with epoxy and the unsound, deteriorated concrete was removed and re-poured in place.

Repair work to the bridge included a total of 1130 linear feet of epoxy crack injection, over 2000 ft² of regular cast in place concrete repair and 810 ft² of deep concrete repair which was also cast in place. The regular concrete repair involved repairing areas up to 2" deep, while the deep repair involved repairing areas up to 16" deep. Much of this work took place during the winter when temperatures fell far below freezing and full containment, heated water and electric blankets had to be used so that the repair work could continue.
