## PROJECT PROFILE

# BRIDGE DECK EPOXY OVERLAY ON SR-19 OVER PALATLAKAHA CREEK

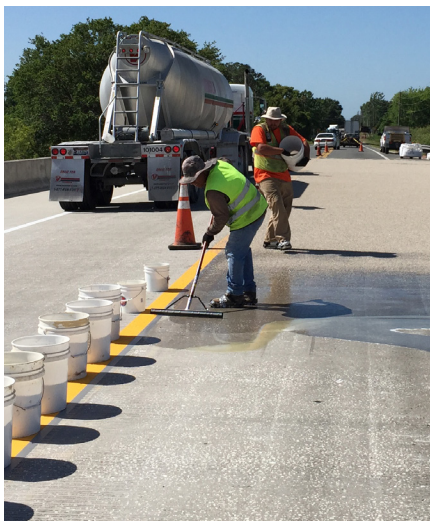
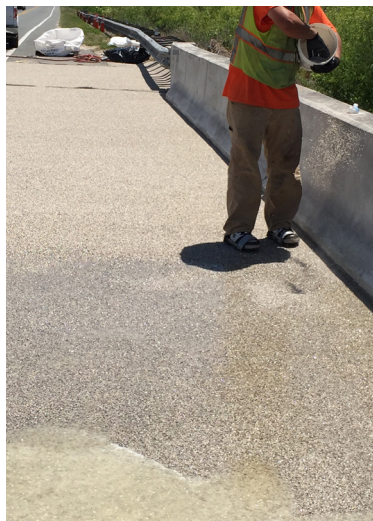
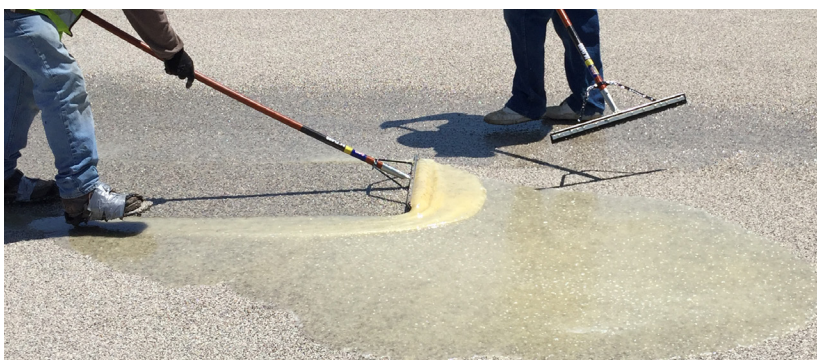
- Bridge built in the year 2000, deck was worn and exhibits long-term shrinkage cracks.
- Seal cracks, protect steel reinforcement from water intrusion, and provide a high friction driving surface with long-term durability.

A full eight hour day was required to shotblast the bridge deck surface, removing dirt, oil stains, and old pavement markers. The following day the deck was pressure washed to remove residual dust latents. Thanks to warm temperatures, the bridge deck was dry by the following morning and ready to be coated.

Flexolith was applied by squeegee at a coverage rate of 40 ft<sup>2</sup>/gal followed by an immediate broadcast of the specified skid-resistant aggregate. In three hours, one lane 22 feet wide and 188 feet long had been covered with the first course of epoxy and aggregate. When the first coat of Flexolith was solid, excess aggregate was removed. The second lift of epoxy and aggregate was applied, 20 ft<sup>2</sup>/gal. After curing ~3 hrs, any remaining unbonded aggregate was removed from the deck. The process was repeated on the adjacent lane.
